Appendix J

Photos

Entrance Stations

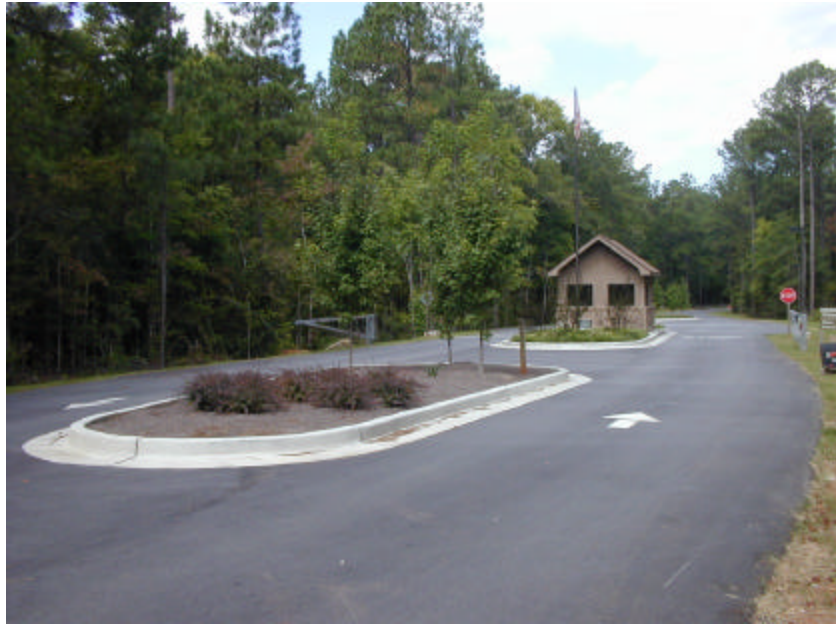
Photo J-1. Entrance station island. Winfield Campground, J. Strom Thurmond Lake, GA. Note recommended center of roadway entrance station location, turnaround incorporated into entrance station approach, and roadway markings to direct traffic flow (Table 3.1)

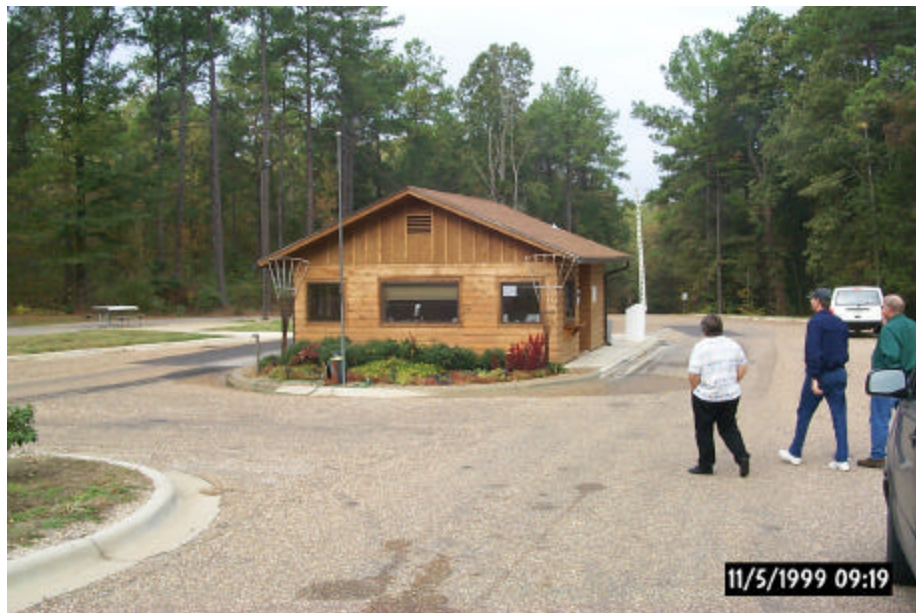
Photo J-2. Entrance station features. Brushy Creek Park, Lake O' the Pines, TX. Note building design and landscaping are in keeping with the theme of the area, and low-maintenance building exterior. Optional dual lanes and recommended turn-around incorporated for customer convenience (Table 3.1)

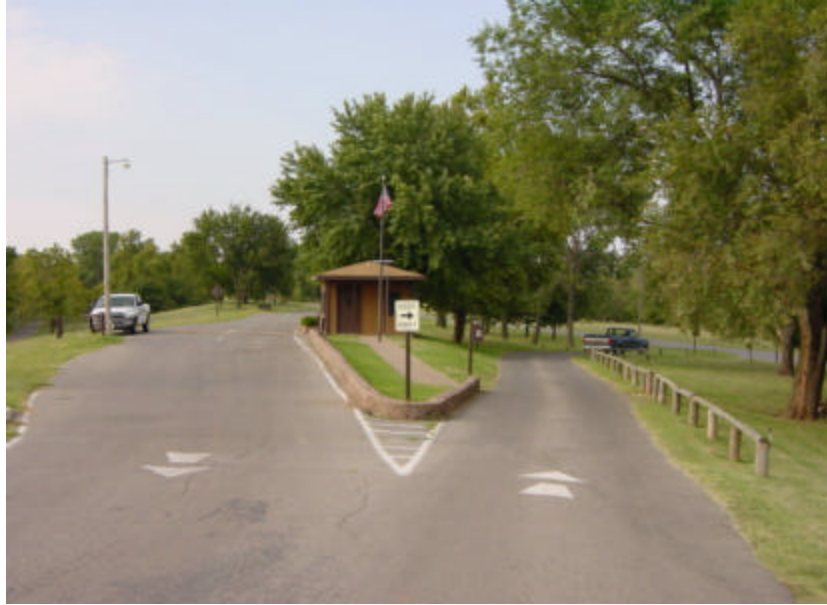
Photo J-3. Dual lanes, Example 1. Canadian Park, Canton Lake, OK. This is the view exiting the park. Note the dual entrance lanes, arrows on pavement designating traffic flow (Table 3.1)

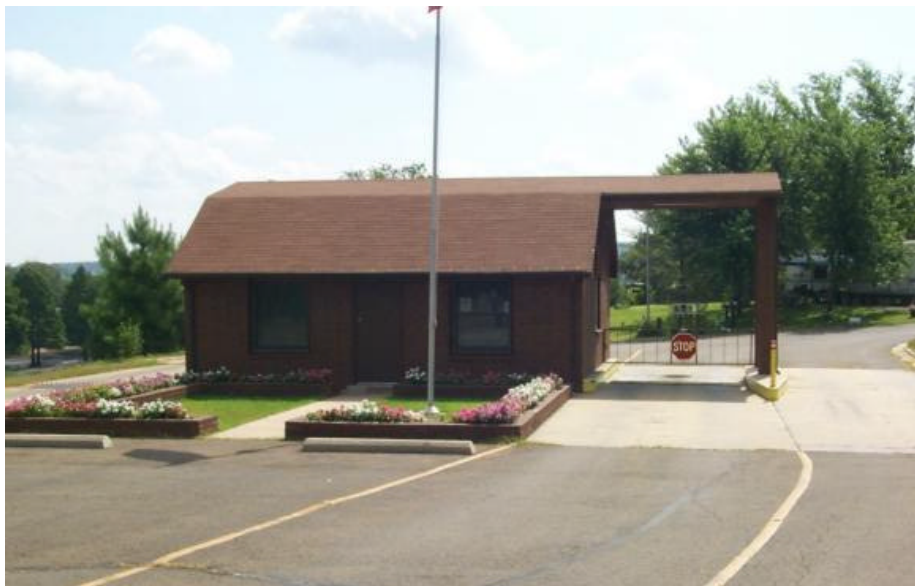
Photo J-4. Dual lanes, Example 2. Taylor Ferry Park, Ft. Gibson Lake, OK. Note dual entrance lanes, traffic control gate, customer parking in front of building so pedestrians do not cross traffic lanes (Table 3.1)

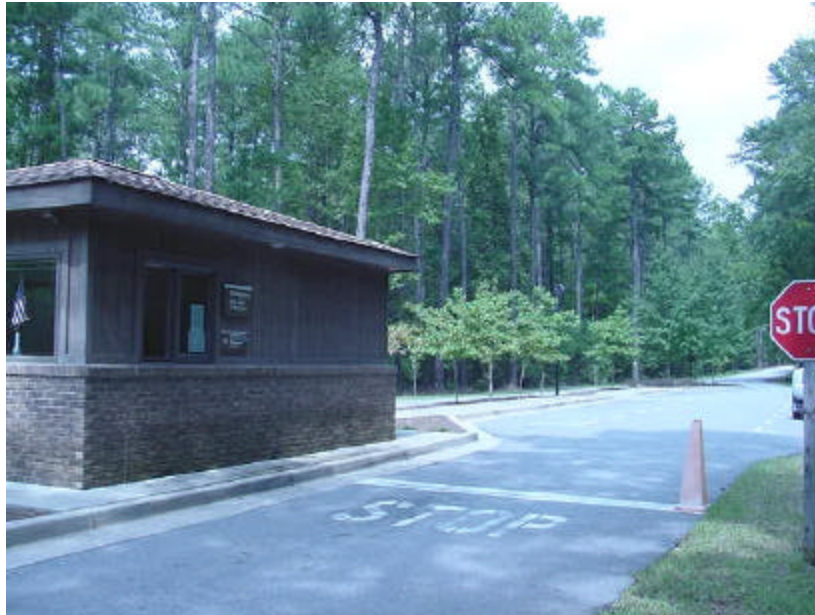
Photo J-5. Customer parking, entrance view. Petersburg Campground, J. Strom Thurmond Lake, SC. Note pullover customer parking area on left so pedestrians do not cross traffic lanes (Table 3.1)

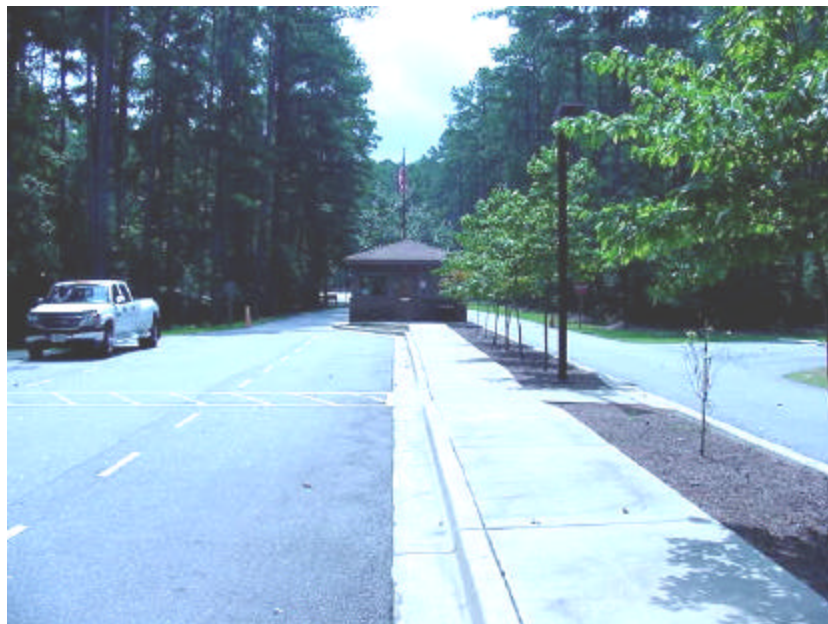
Photo J-6. Customer parking, exit view. Petersburg Campground, J. Strom Thurmond Lake, SC. On left, pullover customer parking on each side of entrance lane for entering customers, and pedestrian crosswalk. On right, head-in parking for exiting customers (Table 3.1)

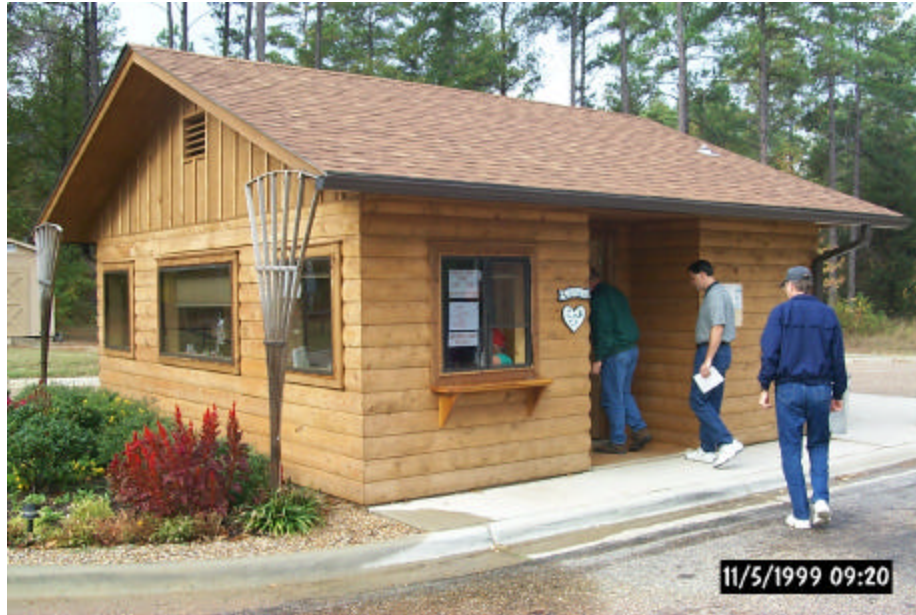
Photo J-7. Customer service window and walk-in area. Brushy Creek Park, Lake O' the Pines, TX. Customers are shown entering walk-in area of entrance station. Note that an outside service window is also provided (Table 3.1)

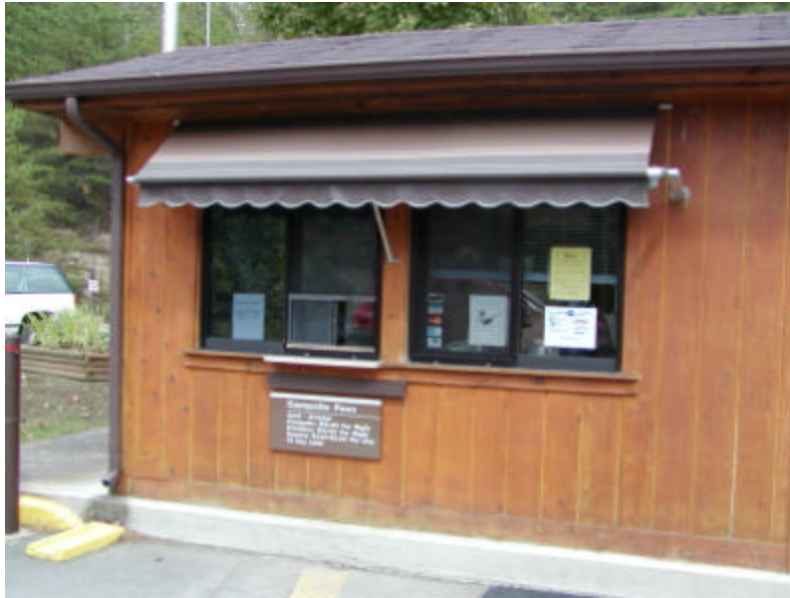
Photo J-9. Customer service window overhang, Example 1. Littcarr Campground, Carr Creek Lake, KY. A retractable RV awning installed to provide customers with protection from the elements while they conduct business at this drive-up outside customer service window (Table 3.1)

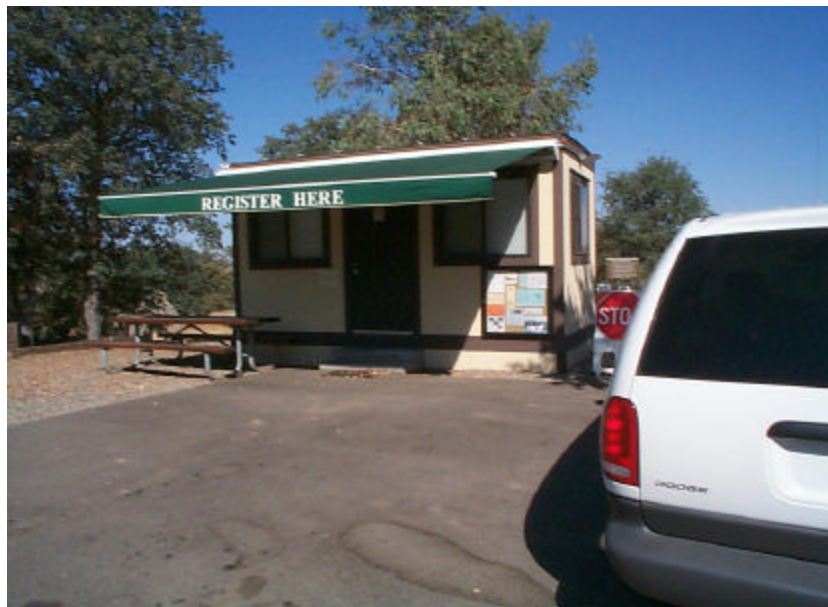
Photo J-10. Customer service window overhang, Example 2. Cordoniz Recreation Area, Eastman Lake, CA. An automated retractable awning is installed at this walk-up outside customer service window (Table 3.1)

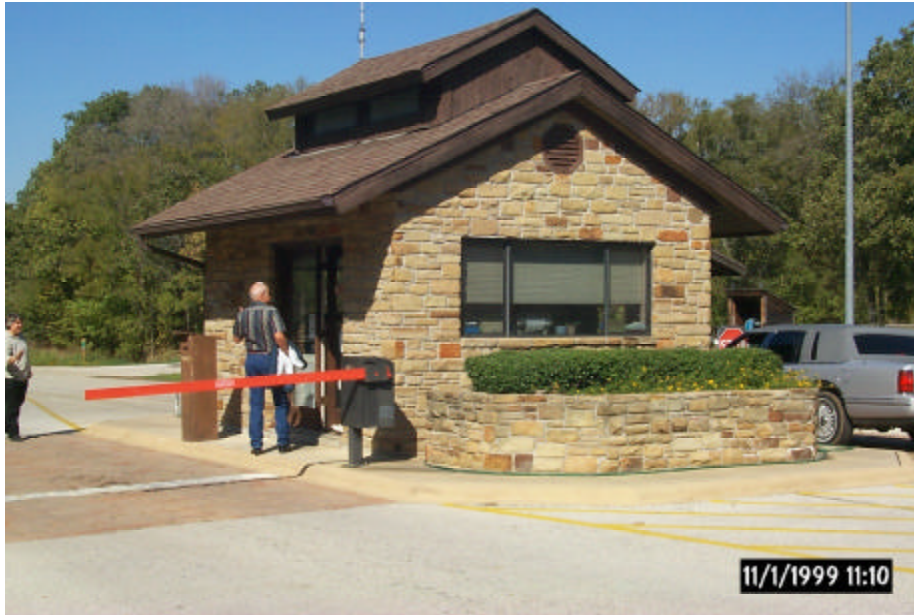
Photo J-11. Automatic gate. Hickory Creek Park, Lewisville Lake, TX. Automatic gate can be operated from inside the entrance station and allows after-hours departures

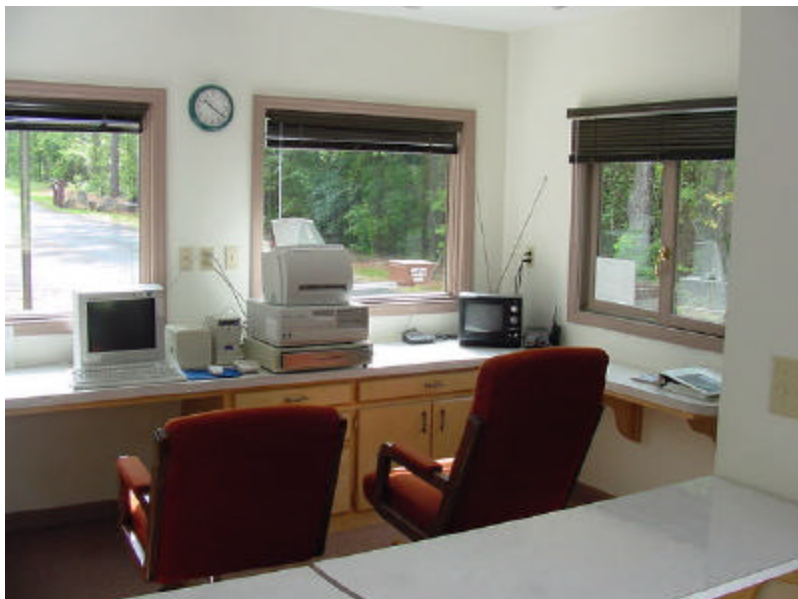
Photo J-12. Interior work area. Ridge Road Campground, J. Strom Thurmond Lake, GA. Interior work area for park attendants sized to accommodate all required equipment (Table 3.1)
